# Air Quality Analysis Report

## Cruise Fish Dive, Inc. Bauer Capitano 5-7cfm

Sample Date: 4/3/2024  
Analysis Date: 4/6/2024  
Report ID: 040624140721  
Taken By: Mark Garcy

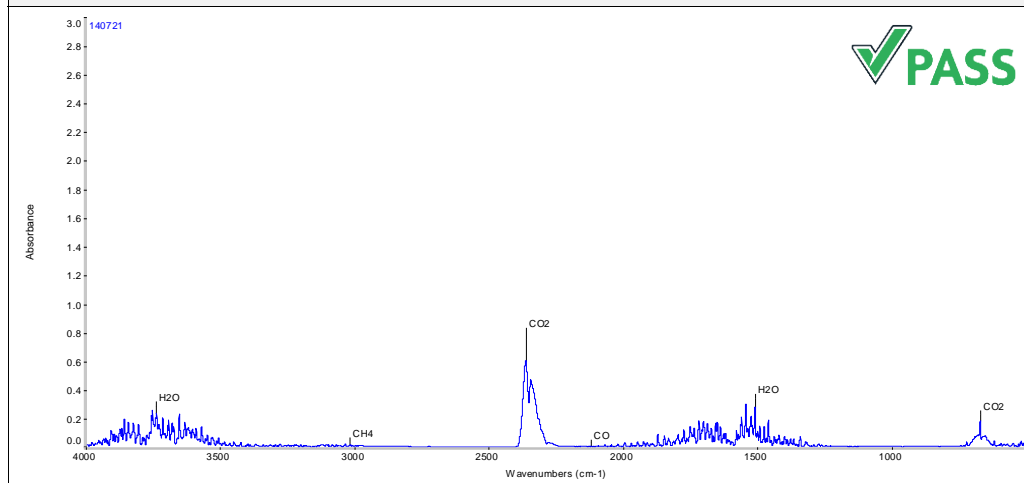
### Instrument Readout

Analytes / Elements	Qtr. 1 4/6/2024				Limits / Range
Oxygen (%)	20.9				20 - 22
Carbon Dioxide (ppm)	512.66				1000
Carbon Monoxide (ppm)	<1				10
Methane (ppm)	<1				25
H2O / Dew Point (ppm/°F)	18.8 / -68.3				67 / -50
Oil & Particles (mg/m3)	<1				5
Unknowns	ND				NA
Odor	ND				None
Sample ID	140721.SPA
